MEMORANDUM

SUBJECT: CONSIDERATION OF TRAFFIC WAY BRIDGE REPLACEMENT PROJECT PROGRAMMING

Bridge Number : 49C0318
Facility Carried: TRAFFIC WAY
Location : ARROYO GRANDE
City : ARROYO GRANDE
Inspection Date : 10/24/2014

Bridge Inspection Report

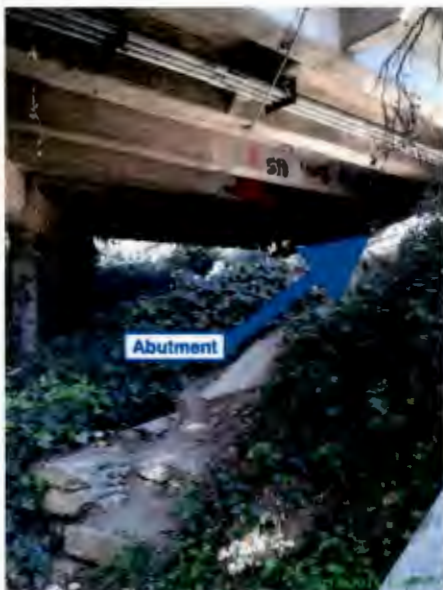
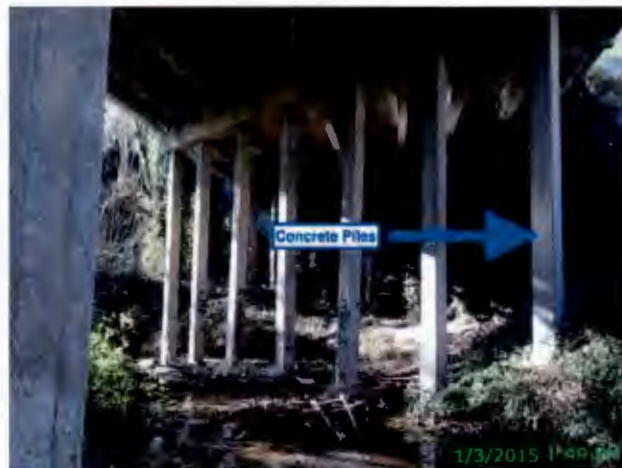
Photos of Traffic Way Bridge

The Traffic Way Bridge was constructed in 1932 making the bridge 83 years old. In general, the design life of a bridge is 100 years. The Traffic Way Bridge is a reinforced concrete structure which is supported by abutments on each end of the bridge as well as concrete piles.

Caltrans completes bridge inspections for the Traffic Way Bridge once every two years. In 2006, the bridge was designated scour critical meaning that the supporting members of the bridge are compromised due to erosions of surrounding soil. The last inspection of the Traffic Way Bridge was completed on October 24, 2014. This inspection found signs of deck cracking, failed expansion joints, spalling concrete, concrete abrasion, and creek channel erosion.

The largest factor making the Traffic Way Bridge eligible for rehabilitation and replacement funds through the Highway Bridge Program is channel scour. Channel scour is the process of flowing water eroding the creek bed away from the bridge. If this erosion occurs adjacent to a bridge's supports, the bridge is then classified as scour critical. It is estimated that the Arroyo Grande creek's channel has been lowered by approximately 12 feet in the last 83 years, which has in-turn reduced the supporting piles' ability to hold up the Traffic Way Bridge.

Staff and Caltrans have conferred on solutions to deal with the scour issue and agree that moving forward with bridge replacement work is the most cost effective solution in this situation. At present time, we have the opportunity to replace the bridge and install a new bridge that will not be as susceptible to creek erosion or scour that will last 100 years or more.
